**Flood Control Project Maintenance
Levee Inspections**

Maintenance Issue Types Only, Levee Inspection Report By Mile - Spring 2017

Reclamation District No. 1500 Sutter Basin

Waterway	Bank	Unit Miles	Inspection Start/End	Inspector
Unit No. 01 Sacramento River	Left	33.15	05/09/2017 05/16/2017	Zach Jojola

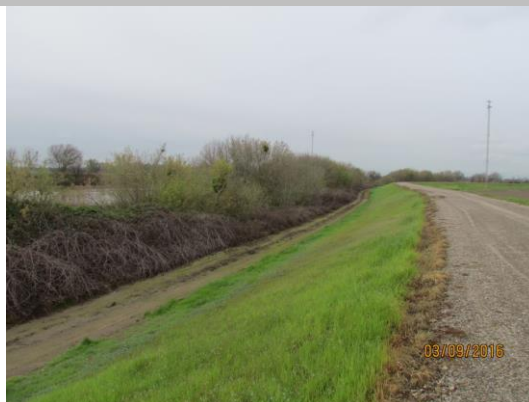
Photo 1 of 2 : SP_2017_RD1500_189_72_20170320_00041.jpg

LM Start	0.56	Rating **	A/W	Issue No.	72
LM End	0.82	Issue Type +	Ma	Location *	WS
Category	Earthen Levee			GPS Latitude/Longitude	
				Start	End
Item	Vegetation			38.764462 °	38.764638 °
				-121.683167 °	-121.687690 °
DWR ID	DWR_RD1500_01_s_2012_72				
Comment Code					
V8 : Environmental Requirements.					
Inspector Comment

View of the revegetation site on the waterward side toe of the levee looking upstream. Spring 2016.

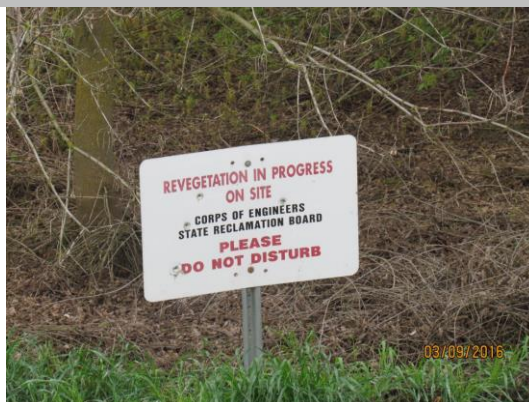
Photo 2 of 2 : SP_2017_RD1500_189_72_20170320_00042.jpg

Sign is located at the toe of the levee on the waterward side. Spring 2016.

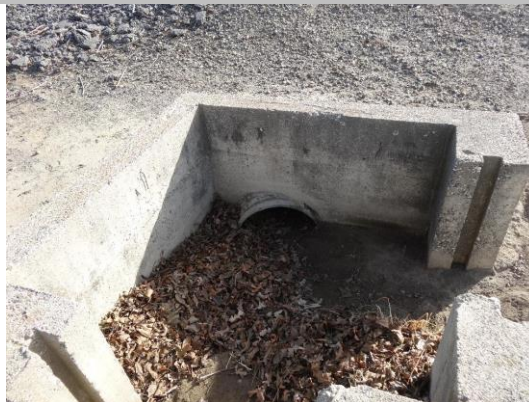
Photo 2 of 3 : UCIP_SP_2017_50197_52424.jpg

FS_ID:50197
DS_ID:20063
EP_NO: 10061
Repair Type: Non-Urgent
Crossing Status: Found
UCIP Comments: 08/29/2016 Same as last inspection. (K. Fazel - UCIP)01/10/2014 Needs proper abandonment. (P. Amatya - DWR)
FIELD_STRUCT_DESC: *ABANDONED* 18-inch corrugated metal drainage pipe through the levee, 15 feet below the crown. Slide gate in 4-foot by 4-foot concrete box at the waterside (WS) toe. Concrete box at the landside (LS) toe. Pipe crosses overflow area to the river.
(Automatic Board Order (ABO) issued as Permit No. 10061, 1974 - Matteoli). [Additional Reference(s): DWR Levee Log, 2005. USACE Sacramento O&M Manual 128, March 1960 (HLM 12.69)].
FS Date: 8/29/2016

LS view: concrete intake box on levee toe.

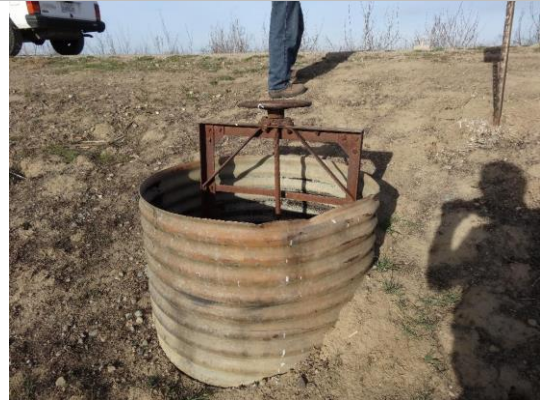
Photo 1 of 3 : UCIP_SP_2017_50196_52467.jpg

WS view: CMP riser with slide gate on levee slope.

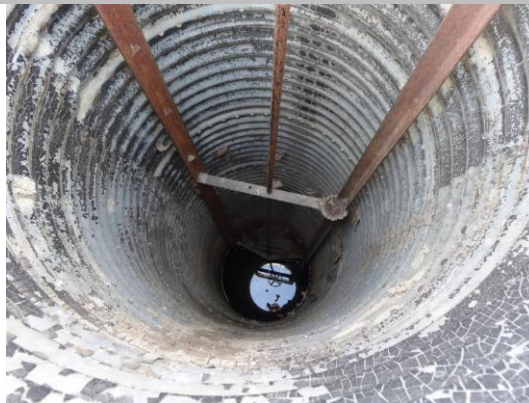
Photo 2 of 3 : UCIP_SP_2017_50196_52466.jpg

WS view: inside view of CMP riser with slide gate.

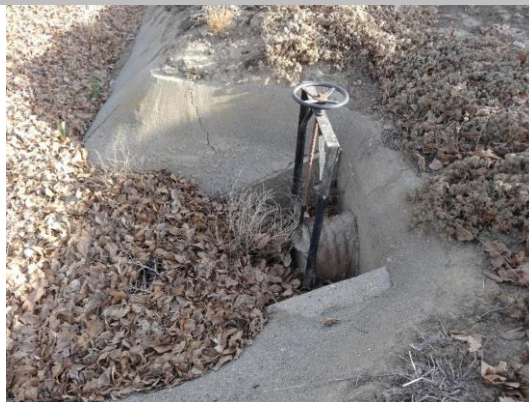
Photo 3 of 3 : UCIP_SP_2017_50196_52465.jpg

LS view: CMP outlet with slide gate and U type headwall on levee toe.

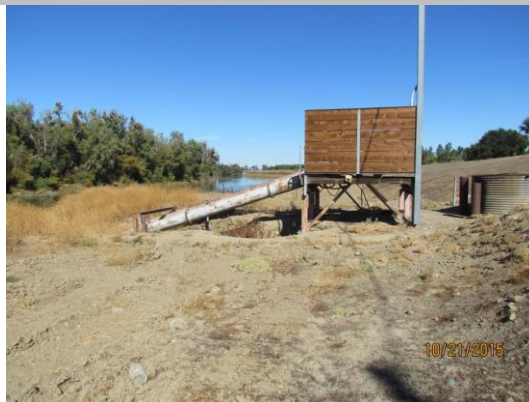
Photo 1 of 3 : SP_2017_RD1500_189_121_20170320_00079.jpg

LM Start	17.34	Rating **	M	Issue No.	121
LM End	17.34	Issue Type +	Ma	Location *	WS
Category	Earthen Levee			GPS Latitude/Longitude	
				Start	End
Item	Erosion / Bank Caving			38.888137 °	38.888137 °
				-121.807273 °	-121.807273 °
DWR ID	DWR_RD1500_01_f_2015_121				
Comment Code					
E2 : Schedule repair of erosion site prior to the next inspection.					
Inspector Comment					
Pipe is causing the erosion on the berm of the levee.

Perspective view of the pump on the waterward side of the levee looking upstream. Fall 2015.

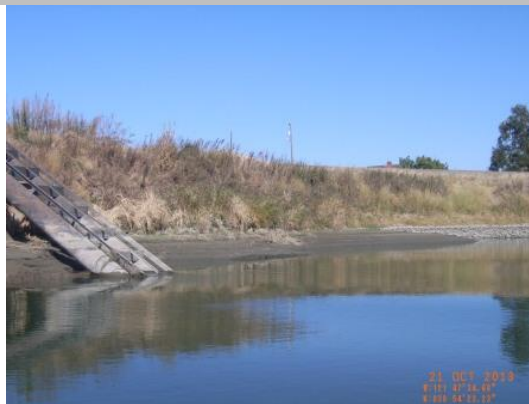
Photo 1 of 1 : SP_2017_RD1500_189_5_20170320_00005.jpg

LM Start	19.16	Rating **	A/W	Issue No.	5
LM End	19.47	Issue Type +	Ma	Location *	WS
Category	Supplemental			GPS Latitude/Longitude	
				Start	End
Item	2015 USACE Erosion Survey, DRAFT			38.904041 °	38.906697 °
				-121.790298 °	-121.792796 °
DWR ID	DWR_RD1500_01_s_2016_5				
Comment Code					
Inspector Comment					
1997 - Cobbles eroded off the clay materials; not much evidence of erosion on the toe; cobble loss on the toe. 2011 - Some minor new erosion. 2015: No observed changes. [2015 Site ID: SAC_104-5_L]

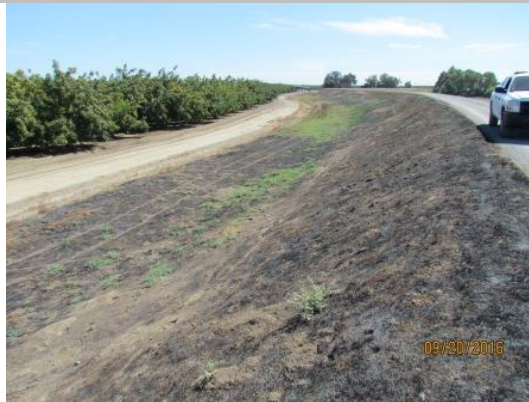
Photo 2 of 3 : SP_2017_RD1500_189_102_20170320_00059.jpg

Landside slope perspective view. Fall 2016.

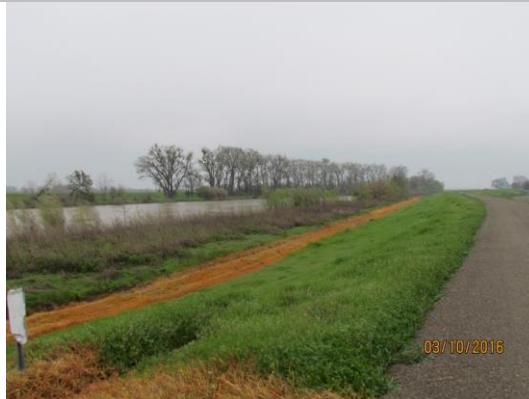
Photo 1 of 2 : SP_2017_RD1500_189_84_20170320_00047.jpg

LM Start	28.94	Rating **	A/W	Issue No.	84
LM End	29.17	Issue Type +	Ma	Location *	WS
Category	Earthen Levee			GPS Latitude/Longitude	
				Start	End
Item	Vegetation			38.988072 °	38.988572 °
				-121.811737 °	-121.807520 °
DWR ID	DWR_RD1500_01_s_2012_84				
Comment Code					
V8 : Environmental Requirements.					
Inspector Comment

View of the revegetation site on the waterward side of the levee looking upstream. Spring 2016.

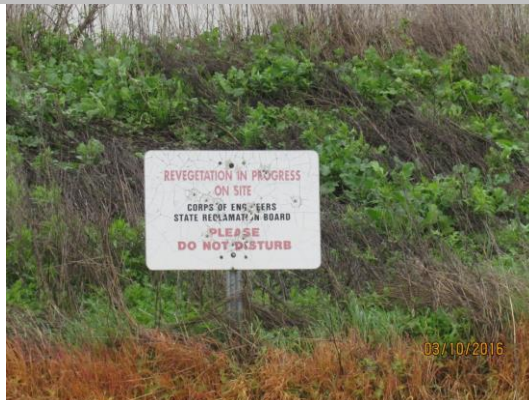
Photo 2 of 2 : SP_2017_RD1500_189_84_20170320_00048.jpg

Sign for the revegetation site. Spring 2016.

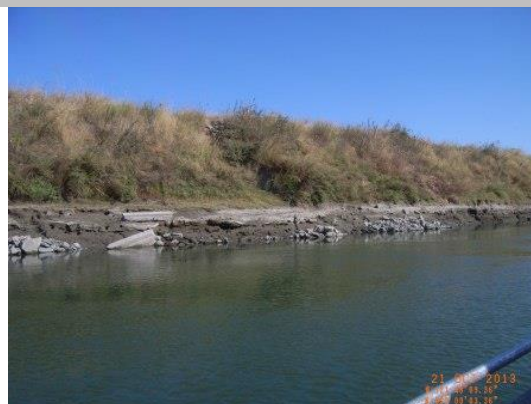
Photo 1 of 1 : SP_2017_RD1500_189_22_20170320_00020.jpg

LM Start	30.60	Rating **	A/W	Issue No.	22
LM End	30.75	Issue Type +	Ma	Location *	WS
Category	Supplemental			GPS Latitude/Longitude	
				Start	End
Item	2015 USACE Erosion Survey, DRAFT			38.999745 °	39.001413 °
				-121.800898 °	-121.802889 °
DWR ID	DWR_RD1500_01_s_2016_22				
Comment Code					
Inspector Comment					
2000 - Eroding, vertical berm slope over a vertical cohesive toe; slow erosion but getting close to the toe. 2002 - Erosion is getting close to the levee, still eroding with some new small slumps. 2004 - Some minor new erosion. 2006 - Some new erosion, cleaned off older scars and slump faces. 2008 - New, small, partial rotational failure. 2011 - Some new minor erosion. 2015: No observed changes. [2015 Site ID: SAC 116-0 L]

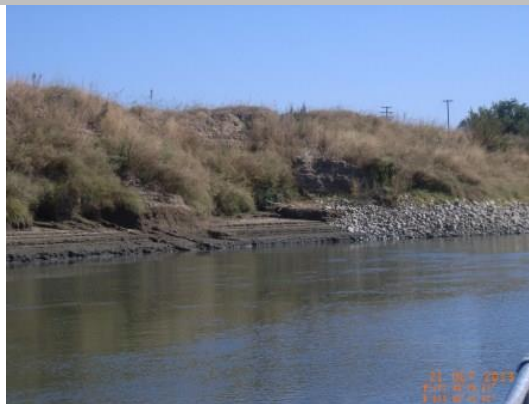
Photo 1 of 1 : SP_2017_RD1500_189_15_20170320_00014.jpg

Comment Code					
Inspector Comment					
2003 - New sedimentation and some new small toe scallops at the upstream end; downstream end has some new erosion. 2004 - Some new erosion at the toe and upper bank and some small new rotational failures (mainly minor, except at the downstream end). 2007 - Some new slumps. 2009 - Some new scallops and site was extended upstream. 2010 - New deposition along upstream end of site, however there is also new erosion throughout the site. Site seems to be worsening, and eroding fast. Large habitat for bank swallows. 2011 - Some new minor erosion. 2012 - Minor new erosion. 2015: No observed changes. [2015 Site ID: SAC_116-5_L]

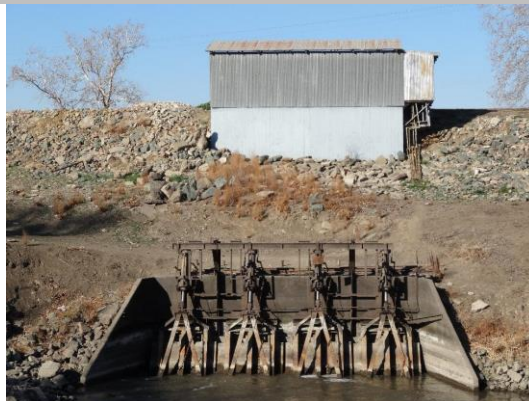
Photo 1 of 3 : UCIP_SP_2017_28886_53098.jpg

WS view: CM shed for slide gate on levee shoulder (top) and outfall structure at levee toe (bottom).

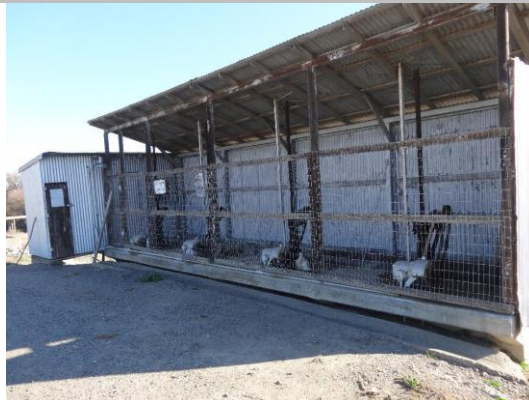
Photo 2 of 3 : UCIP_SP_2017_28886_53096.jpg

WS view: motorized slide gates in CM shed on levee shoulder.

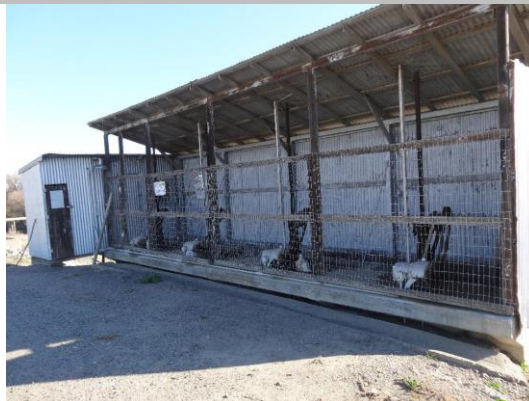
Photo 2 of 3 : UCIP_SP_2017_28883_53083.jpg

WS view: motorized slide gates in CM shed on levee shoulder.

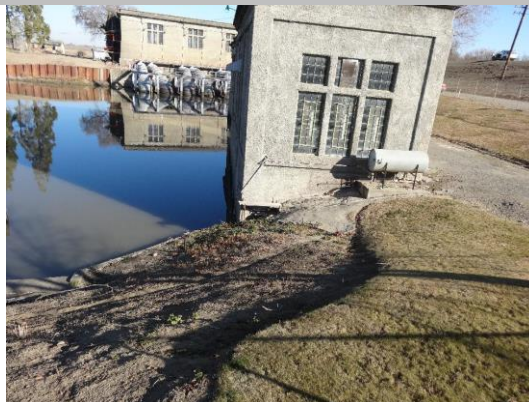
Photo 3 of 3 : UCIP_SP_2017_28883_53084.jpg

LS view: pump house at the end of levee berm.

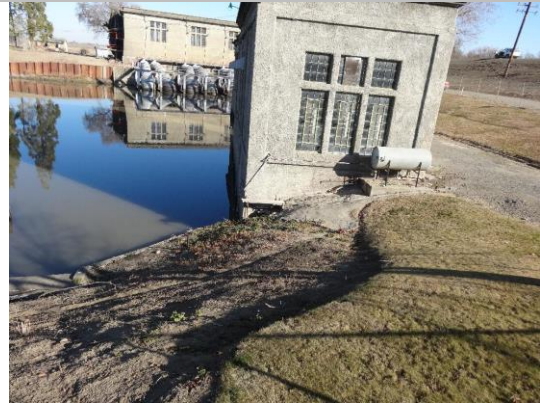
Photo 3 of 3 : UCIP_SP_2017_28884_53099.jpg

LS view: pump house at the end of levee berm.

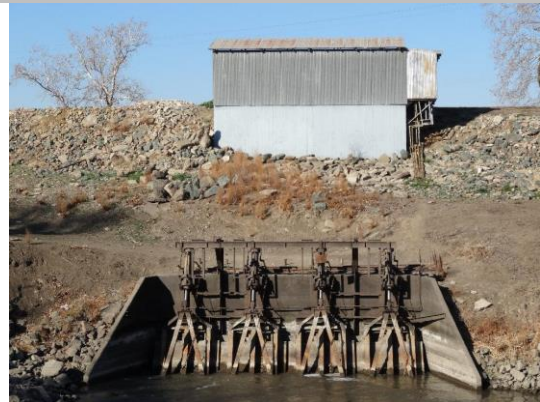
Photo 1 of 3 : UCIP_SP_2017_28885_53095.jpg

WS view: CM shed for slide gate on levee shoulder (top) and outfall structure at levee toe (bottom).

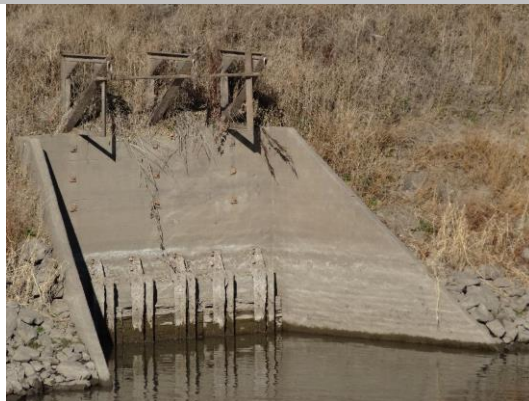
Photo 1 of 3 : UCIP_SP_2017_28954_53260.jpg

WS view: U type concrete headwall and flap gates on levee toe.

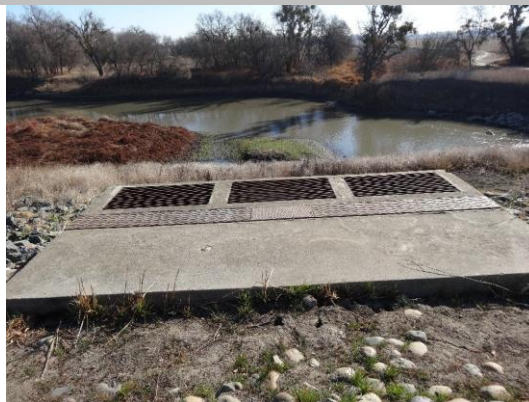
Photo 2 of 3 : UCIP_SP_2017_28954_53259.jpg

WS view: concrete surge structure on waterside shoulder.

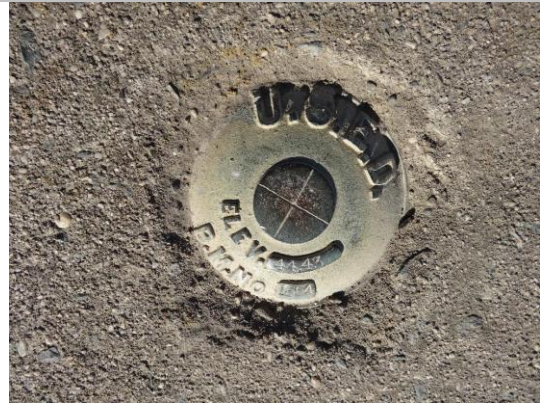
Photo 3 of 3 : UCIP_SP_2017_28954_53262.jpg

WS view: USED Bench Mark on concrete structure on levee shoulder.

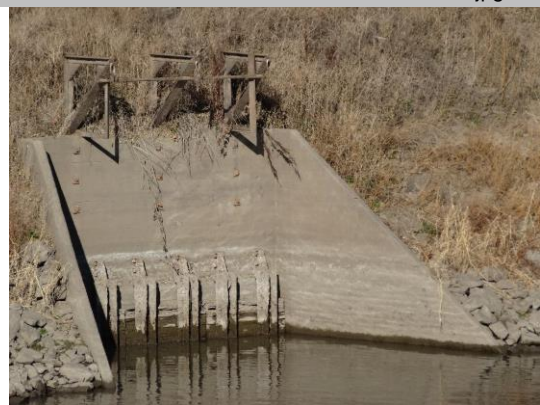
Photo 1 of 3 : UCIP_SP_2017_28955_53265.jpg

WS view: U type concrete headwall and flap gates on levee toe.

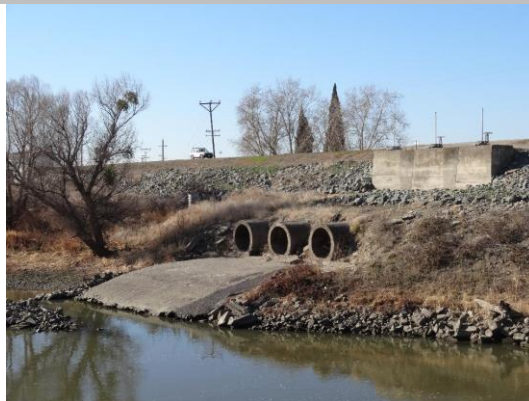
Photo 1 of 3 : UCIP_SP_2017_28892_53147.jpg

WS view: outfall structure on levee toe and concrete box on levee shoulder.

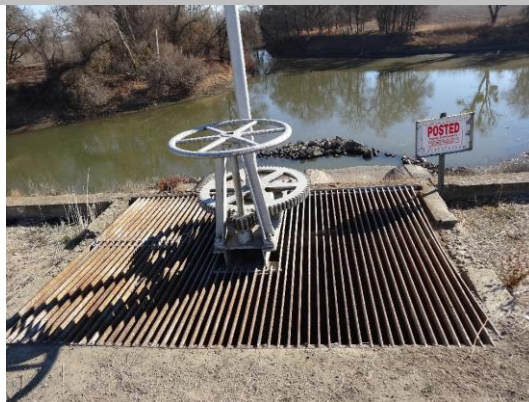
Photo 2 of 3 : UCIP_SP_2017_28892_53146.jpg

WS view: slide gate in concrete box on levee shoulder.

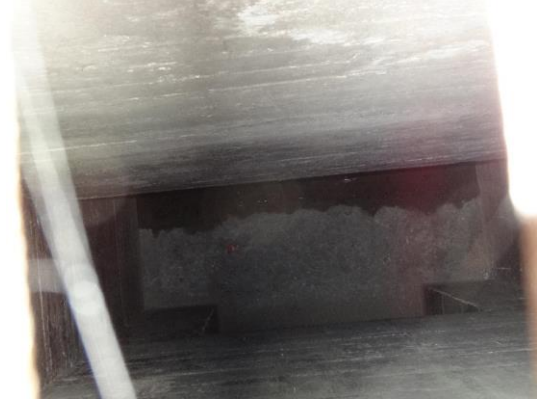
Photo 3 of 3 : UCIP_SP_2017_28892_53145.jpg

LM Start	1.98	Rating **	A/W	Issue No.	31 (cont)
LM End	1.98	Issue Type +	Ma	Location *	WS
Category	Supplemental			GPS Latitude/Longitude	
				Start	End
Item	DWR UCIP LMA Responsibility			38.784818 °	38.784818 °
				-121.654778 °	-121.654778 °
DWR ID					
Comment Code					
Inspector Comment					
FS_ID:28892 DS_ID:20092 EP_NO: 10088 Repair Type: No Action Needed Crossing Status: Found UCIP Comments: Pumping plant was working during the field visit. Three 8.5 ft. X 8.5 ft. concrete box on waterside shoulder. FIELD_STRUCT_DESC: 2 of 3: Three 7-foot by 7-foot concrete culverts through levee 24.0-feet below crown. Pumps in concrete pump house on landward side. Slide gates on concrete structure on waterward slope. Discharge in concrete spillway and borrow pit. Ramp on waterward slope. (ABO No. 10088 R.D. 1500). O&M Manual Sac 129, June 1954. Latest revision March 2011. FS Date: 1/21/2014

WS view: inside view of concrete box on levee shoulder.

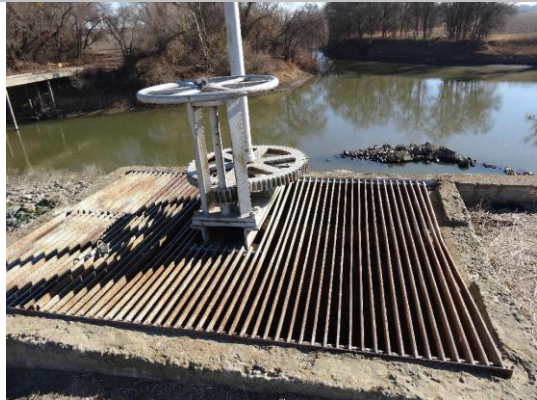
Photo 1 of 3 : UCIP_SP_2017_28893_53157.jpg

Comment Code					
Inspector Comment					
FS_ID:28893					
DS_ID:20093					
EP_NO: 10088					
Repair Type: No Action Needed					
Crossing Status: Found					
UCIP Comments: Pumping plant was working during the field visit.Three 8.5 ft. X 8.5 ft. concrete box on waterside shoulder.					
FIELD_STRUCT_DESC: 3 of 3: Three 7-foot by 7-foot concrete culverts through levee 24.0-feet below crown. Pumps in concrete pump house on landward side. Slide gates on concrete structure on waterward slope. Discharge in concrete spillway and borrow pit. Ramp on waterward slope. (ABO No. 10088 R.D. 1500). O&M Manual Sac 129, June 1954. Latest revision March 2011.					
FS Date: 1/21/2014

WS view: slide gate in concrete box on levee shoulder.

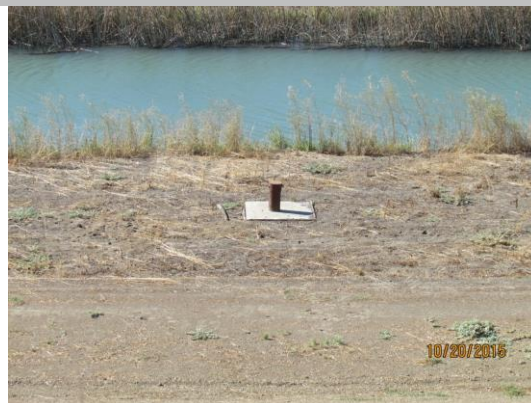
Photo 3 of 3 : SP_2017_RD1500_190_4_20170320_00004.jpg

LM Start	14.13	Rating **	U	Issue No.	4 (cont)	
LM End	14.13	Issue Type +	Ma	Location *	LS	
Category	Earthen Levee			GPS Latitude/Longitude		
				Start		End
Item	Underseepage Relief Wells			38.947628 °	38.947628 °	
				-121.669764 °	-121.669764 °	
DWR ID	DWR_RD1500_02_s _ 2012_4					
Comment Code						
Inspector Comment						
Concrete pad and PVC underneath is broken.

View of the relief well at historical boil 12. Fall 2015.

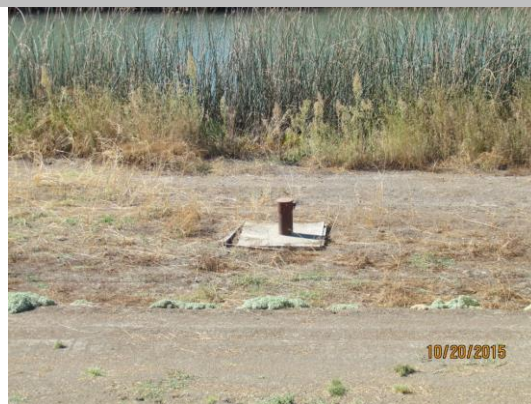
Photo 1 of 1 : SP_2017_RD1500_190_11_20170320_00005.jpg

LM Start	14.47	Rating **	A/W	Issue No.	11
LM End	14.47	Issue Type +	Ma	Location *	LS
Category	Earthen Levee			GPS Latitude/Longitude	
				Start	End
Item	Underseepage Relief Wells			38.951413 °	38.951413 °
				-121.673856 °	-121.673856 °
DWR ID	DWR_RD1500_02_s _ 2012_11				
Comment Code					
Inspector Comment

A relief well at historical boil 16. Fall 2015.
